Annual Inspection Report
Word Field Municipal Airport

# ANNUAL INSPECTION REPORT MARCH 7, 2011

SCOTTSBORO MUNICIPAL AIRPORT WORD FIELD SCOTTSBORO, ALABAMA

March 7, 2011

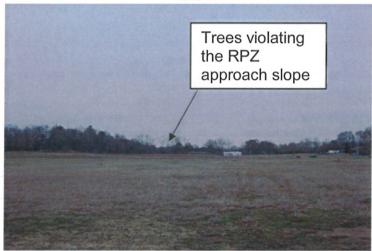
- → <u>Violation</u> Runway 04 is obstructed by trees and brush, reducing the required 20:1 slope to 18:1. The trees are located across the Approach/Departure Path at an average distance of 1080 feet from the runway end. Trees obstructing the FAA Runway Protection Zone also continue across the existing railway.
- → <u>Maintenance</u> Runway 22 The 20:1 slope required within the FAA Runway Protection Zone is obstructed by trees located 1105 feet from the runway end and 254 feet from centerline that reduce the approach slope to the runway end to 11:1. The runway is displaced 230 feet. The obstruction clearance slope from the trees to the runway is 16:1.

Runway 22 Approach (See Appendix 3)

- Runway 22 The obstructing trees must be removed or the runway threshold displaced an additional 305 feet from the present location for a total of 535 feet.
- Runway 4 The obstructing trees must be removed or the runway threshold displaced 283 feet to provide the required 20:1 slope. The displacement may also bring other obstructing trees that are growing along both sides of the railway into the displaced Runway Protection Zone.

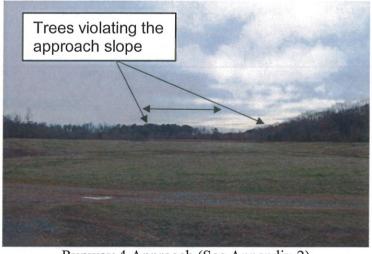
Photo 2

Runway 4 Approach (See Appendix 2)

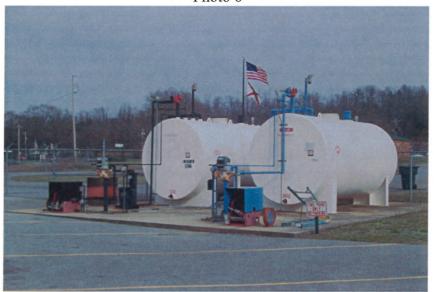
→ The fueling area meets the requirements established by the Alabama Department of Transportation. However, the State of Alabama Department of

Agriculture and Industries may have additional requirements for fueling systems that were not considered during this inspection.

Fueling facility for Jet A and Avgas

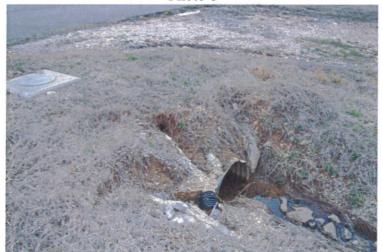
Photo 8

→ The drainage pipe from the taxiway to the ramp has significant erosion at both ends of the structure. Pavement on one side of the taxiway is being undermined by water from the apron which will cause a collapse of the pavement if not corrected.

Erosion on other end of the same drainage structure

→ The airport engineer should be consulted to determine a course of action to repair the eroded areas and prevent future erosion.

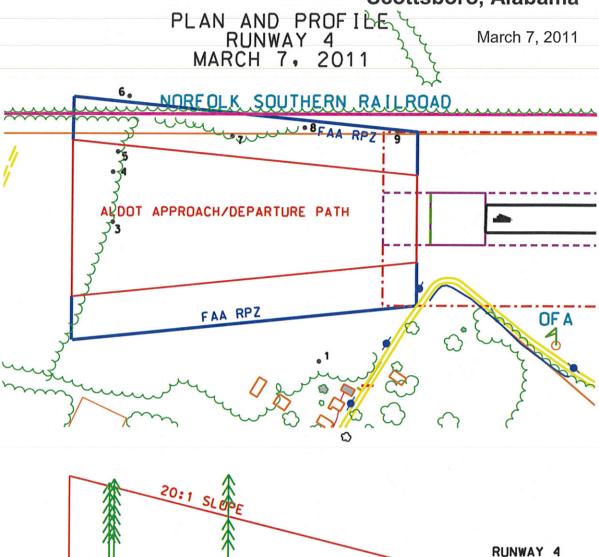
**APPENDIX 2**

VIOLATIONS OF THE 20:1 SLOPE WITHIN THE ALDOT APPROACH/DEPARTURE PATH

3. +46 FOOT TREE 1083 FEET FROM RUNWAY END 11 FEET FROM CENTERLINE 19:1 SLOPE

5. +48 FOOT TREE 1069 FEET FROM RUNWAY END 191 FEET FROM CENTERLINE 18:1 SLOPE

TREES IDENTIFIED ARE PART OF A LINE OF TREES THAT ALSO VIOLATE THE FAA RPZ AND THE 20:1 SLOPE WITHIN THAT AREA. THIS LINE OF TREES EXTENDS ACROSS THE RAILWAY.
